# Manhole Inspection Summary

Manhole # S39Y1\_013MH

**Location** Address: **415 Pontiac Ave**

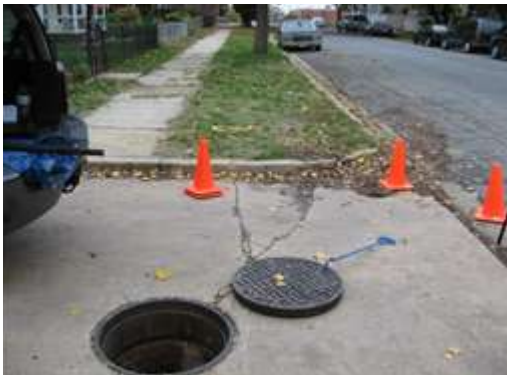
Location View

415 Pontiac Ave

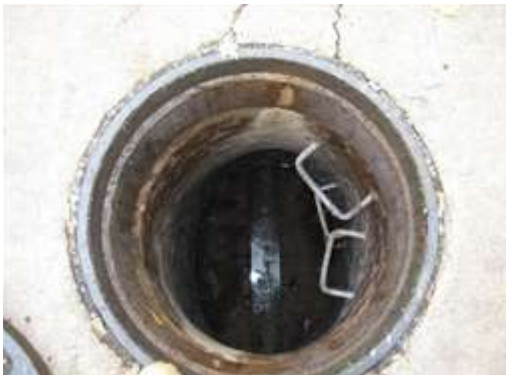
Top View

steps

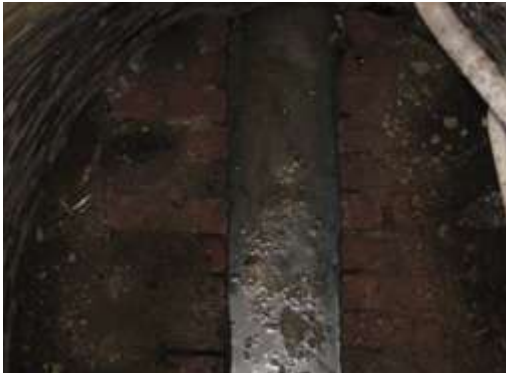
Defect 2

debris

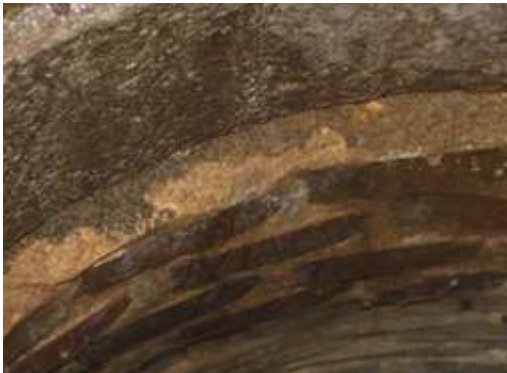
Defect 1

**Frame** Offset: **1** (in.) Condition: ☒ Sound ☐ Cracked ☐ Leaks

frame offset

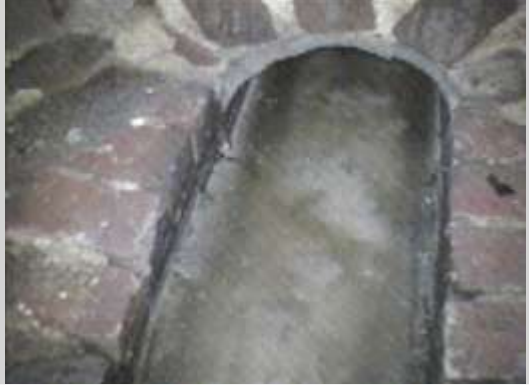
12 O'Clock Outflow

8 in. Circular Gravity Sewer  
Pipe Out @ 12 O'Clock

Deposits: ☐ None ☐ Mud ☒ **Sludge** ☐ Debris ☐ Grease

Silt Depth: **1** (in.) Deposits Extent: **Light**

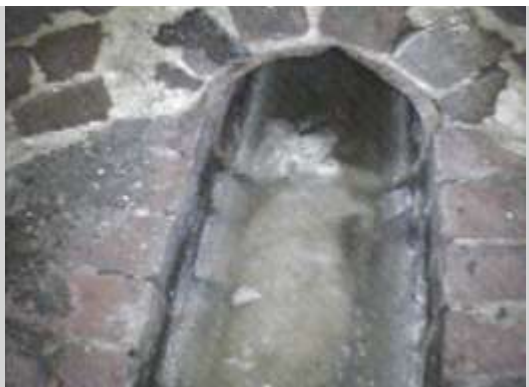
6 O'Clock Inflow

8 in. Circular Service Sewer  
Pipe In @ 6 O'Clock
